# LM GUIDE & BALL SCREW

## Assembly Instructions

## SUMMARY FOR LM GUIDE & BALL SCREW INSTRUCTIONS

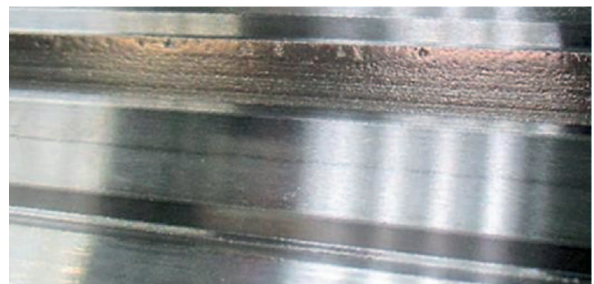
**Failure mode :** **Burning**

- Poor Lubrication.
- Excessive Load.
- Wrong Selection of LM Guide Size.

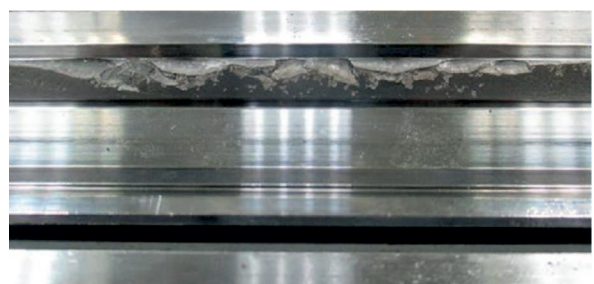
**Failure mode :** **Cracks**

- Excessive External Impact Force.
- Poor Circulation of Balls or Rollers.

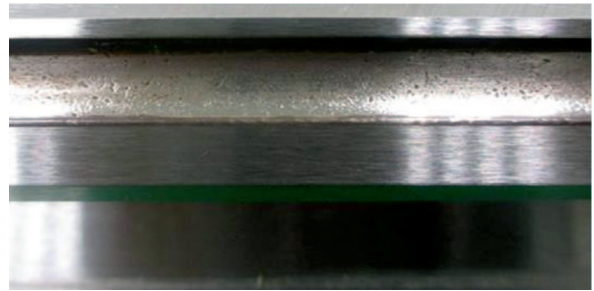
### Failure mode : **Flaking**

- Improper LM Guideway size selection.
- Excessive Load.
- Poor Lubrication.
- Particle Invasion.

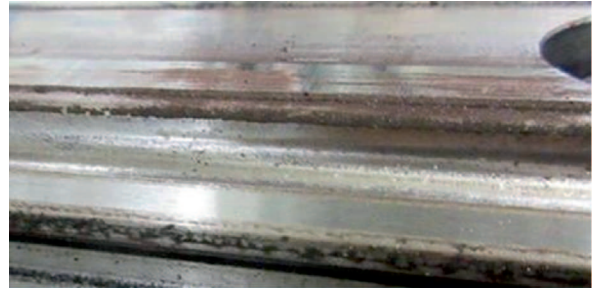
### Failure mode : **Rust & Corrosion**

- Poor Lubrication & Maintenance.
- Coolant Invasion.
- High-Humidity Environment.

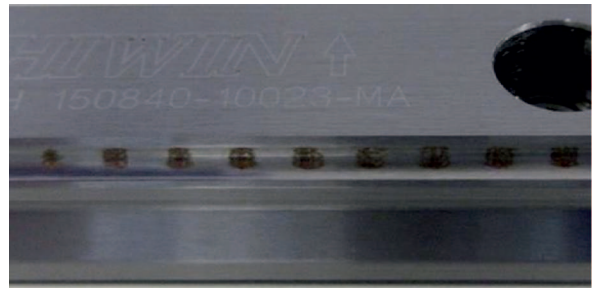
### Failure mode : **Fretting Corrosion**

- Micro-Motion (Short Stroke).
- Poor Lubrication.
- Excessive Load.

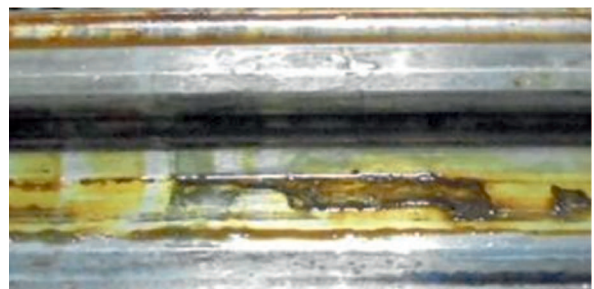
### Failure mode : **Water or Coolant Invasion**

- Water or Coolant solution Invasion.
- Harsh Environment.

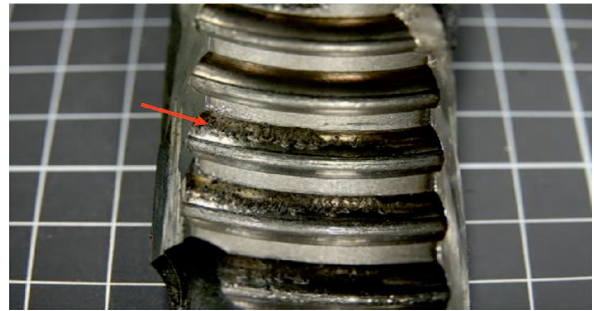
### Failure mode : **Flaking**

- Improper Ball Screw Selection.
- Excessive Loading.
- Poor Lubrication.

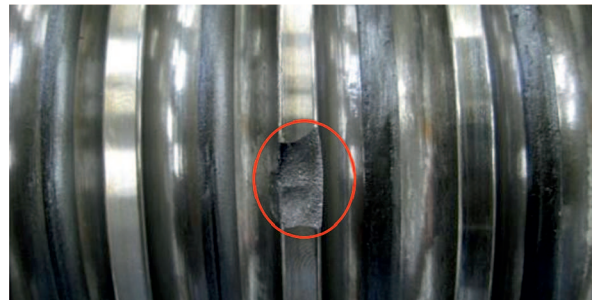
### Failure mode : **Cracks**

- Excessive External Impact Force.
- Poor Re-circulation of Balls.

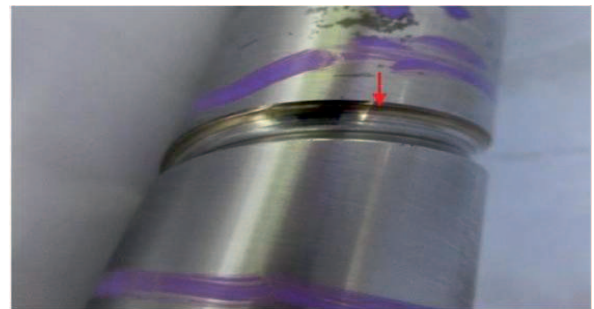
### Failure mode : **Burning**

- Poor Lubrication.
- Excessive Load
- Wrong Selection of Nut Size.

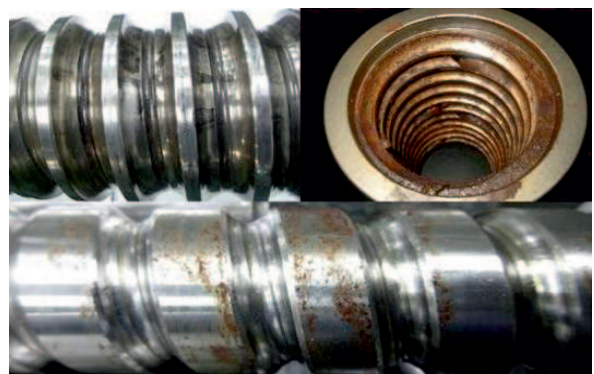
### Failure mode : **Rust & Corrosion**

- Poor Lubrication & Maintenance.
- Coolant Invasion.
- High-Humidity Environment.

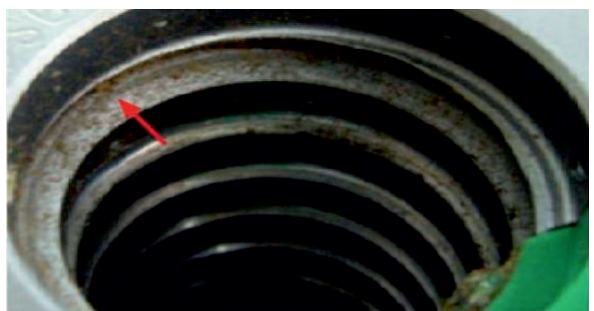
### Failure mode : **Foreign Body Invasion**

- Improper Dust Proof Selection.
